The following report was generated and issued by the United States Army Corps of Engineers (USACE) Engineer Research and Development Center (ERDC) in March 2011. In the time since this product evaluation and report were created, both the product name and sponsoring company have changed.

US Army Corps
of Engineers®
Engineer Research and
Development Center

Evaluation of Rapid Installation Barrier System (RIBS) Flood Fighting Barrier

March 2011

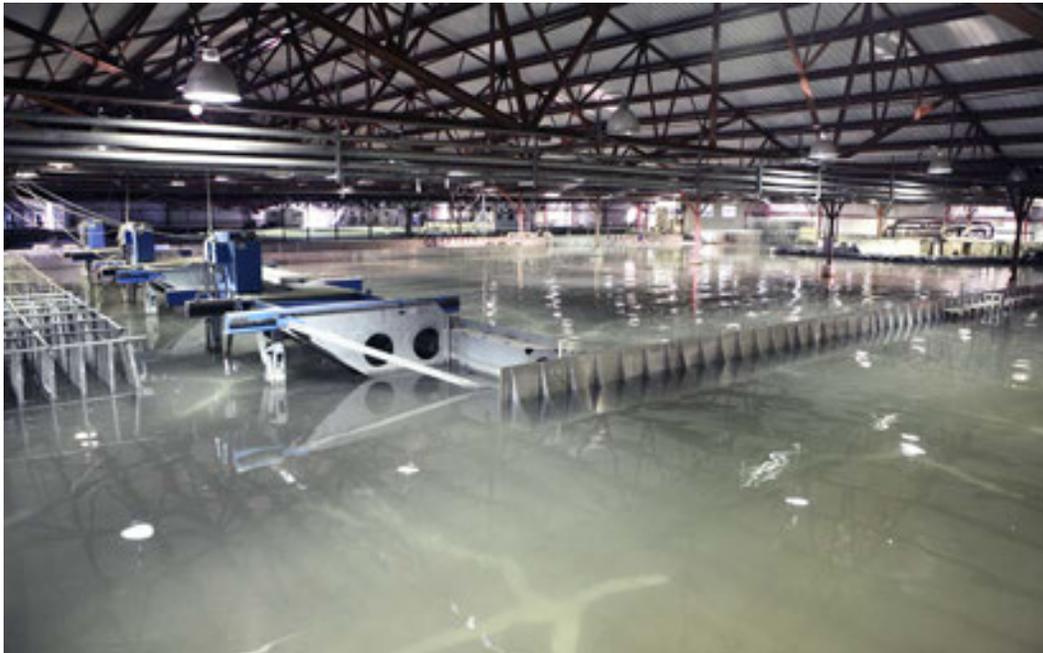
Figure 1. Research basin with wave machines on the left side and the test area on the far right. The test area is shown in closer view in Figure 2 and Figure 3.

The test facility was laid out along the perimeter wall of a reservoir with dimensions of 115 ft by 185 ft by 4 ft deep (Figure 1). The test facility was reconfigured specifically for innovative flood-fighting experiments by allowing levees to be constructed against two wall abutments with a 30-ft opening between the walls (Figure 2). A geometric testing zone footprint was laid out on the concrete floor and all levees were required to be constructed within this given footprint. One side of the footprint abuts the concrete wall at a 90-deg angle, and the other side abuts the concrete wall at a 63-deg angle (Figure 3). The purpose for having two different angles is to simulate real-world geometric variability and demonstrate constructability and geometric flexibility of each vendor’s product. Additionally, the unsymmetrical geometry allows wave loading variability during hydrodynamic testing, and it causes an apparent current along the 63-deg wall.

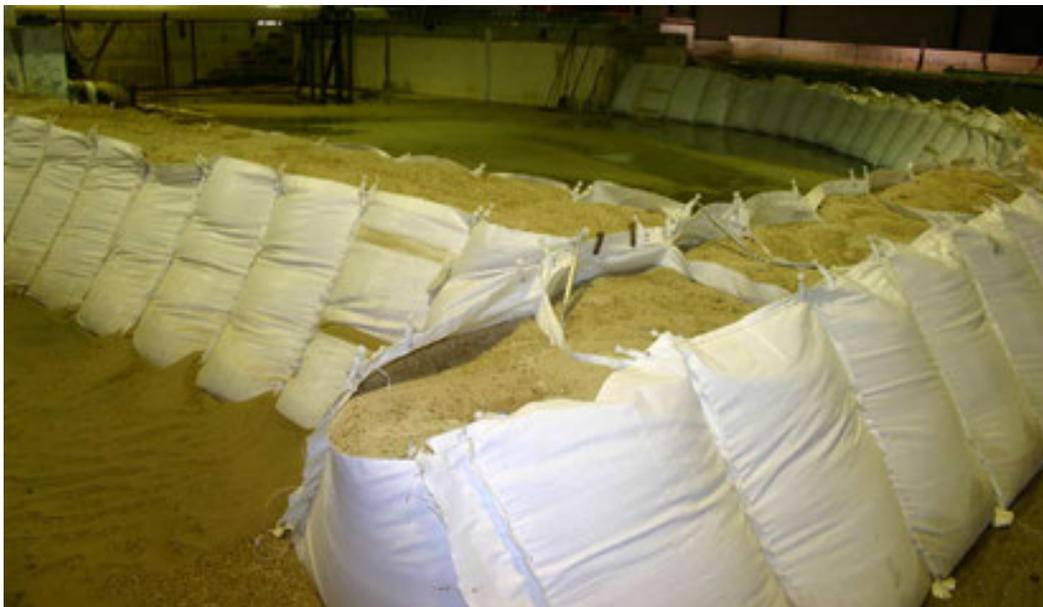
Figure 2. Test area surrounded by the RIBS flood fighting barrier at the conclusion of test protocol.

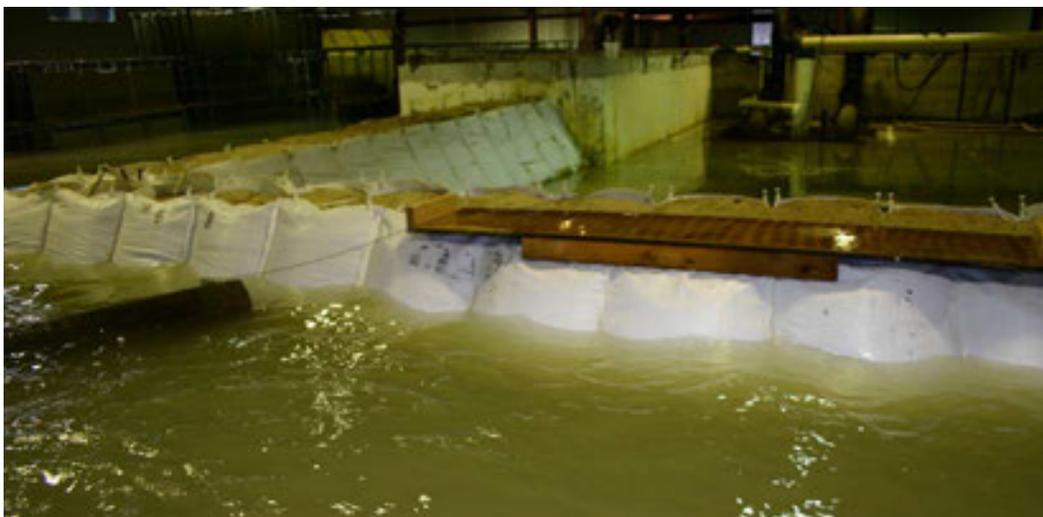
Figure 4. Test area after debris-impact test showing the sump in the back corner of the test area.

Inside the protected area (leeward side of the levee), an 8-ft diameter by 8-ft-deep circular pit was installed to catch any seepage or overflow water from the structure (Figure 4). Two 4-in.-diam pumps were installed in the pit to pump the accumulated water back into the wave basin. Two 12-in.-diam pumps (12 in. intake and 10 in. output) were also installed to pump excess water out of the pit when the capacity of the 4-in. pumps was exceeded.

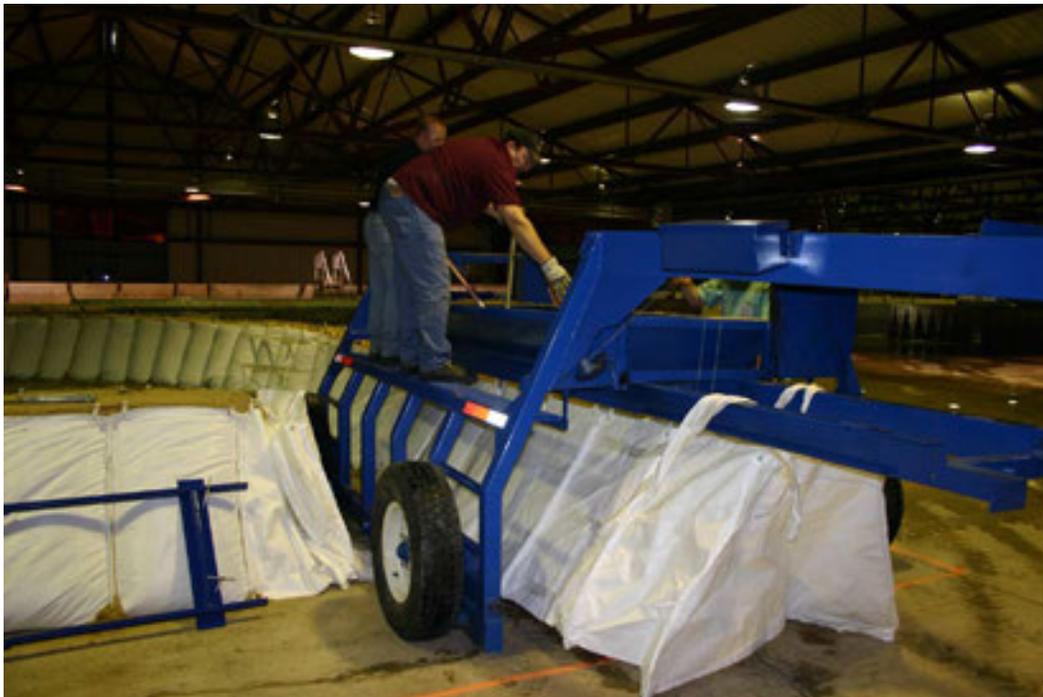
Figure 5. RIBS units being filled with sand through the hopper on the deployment trailer.

Plastic pegs attached to the top of the bags allow the bags to be hung from a rack on the deployment trailer. One or more units of 24 bags is hung at the front of the trailer. Six bags (12 ft) are pulled back under the hopper located on the top of the deployment trailer. The rail system on which the bags are hung extends the length of the trailer. The rails allow the bags to be slid back under the hopper and hold the tops of the bags open for filling. A front-end loader fills the entire 12-ft-long section of bags at one time, then the trailer advances 12 ft leaving the filled bags behind. The next 12-ft of bags is filled, and the trailer advances again.

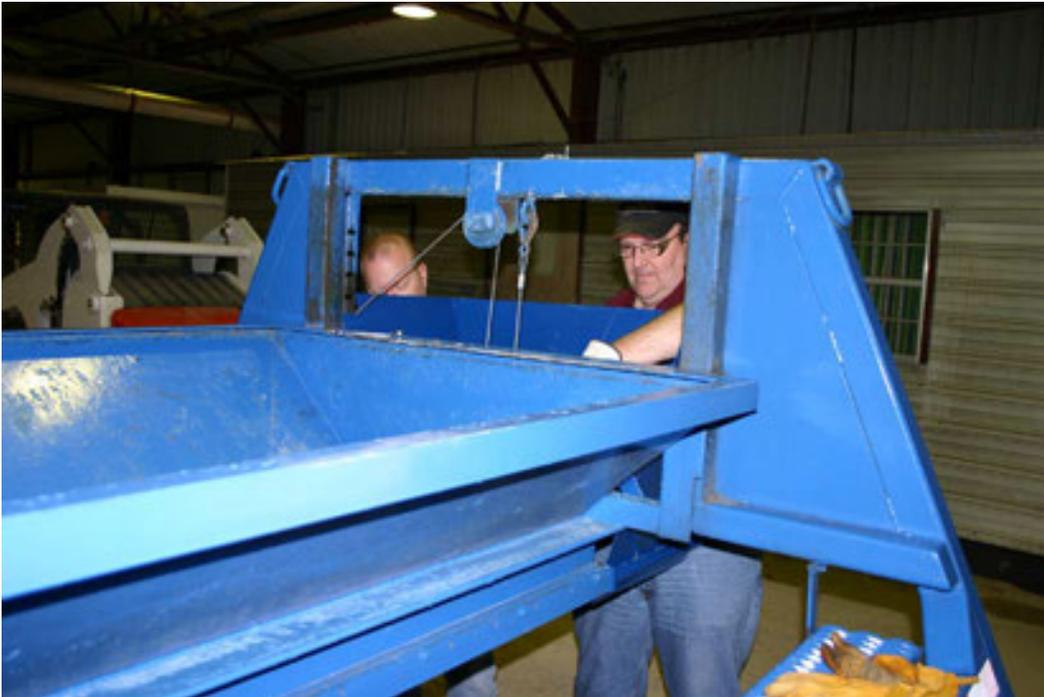
Figure 6. Hopper being lowered on deployment trailer.

Before constructing the test barrier, the deployment trailer required some minor work to change it from its shipping form to deployment form. The trailer was shipped with the hopper secured and the wheels inside the framework. The hopper was freed and lowered to the correct height (Figure 6), and the four wheels were moved from inside the trailer frame to outside the frame. The work took three men 24 minutes to complete. A Bobcat™ skid-steer loader was used to raise one end of the trailer for moving the wheels. The only other tool required was a ratchet set.

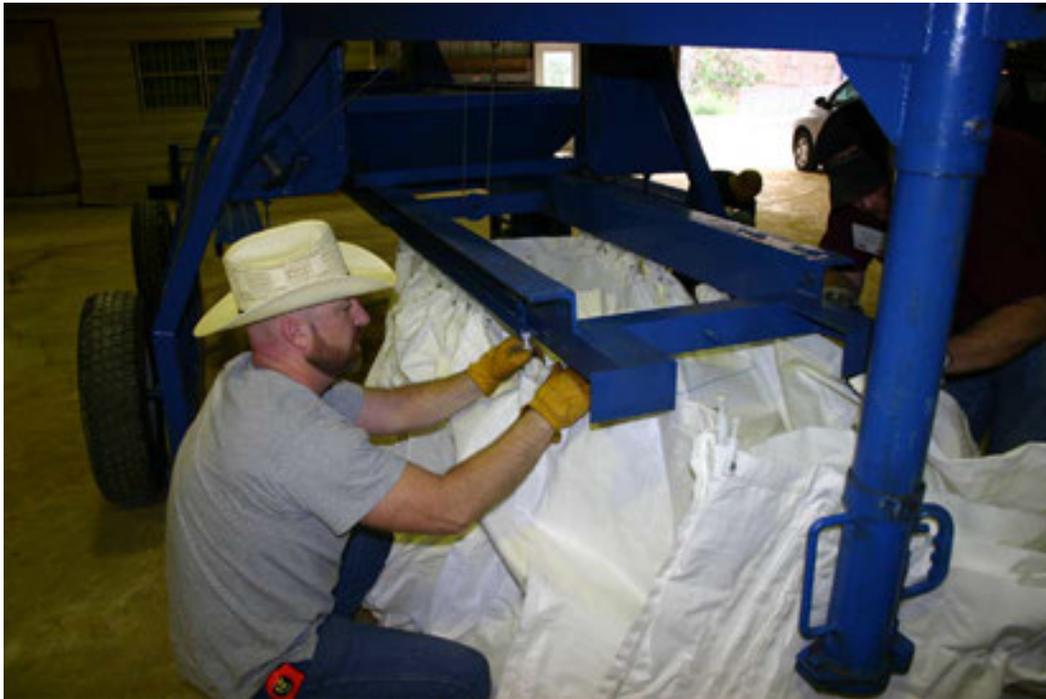
Figure 7. A 24-ft-long set of bags being loaded on the rails of the deployment trailer.

A set of bags (one 24-ft-long unit) was loaded onto the rails of the trailer and pushed to the forward end of the rails (Figure 7), then the last 12 ft of bags were stretched out under the hopper.

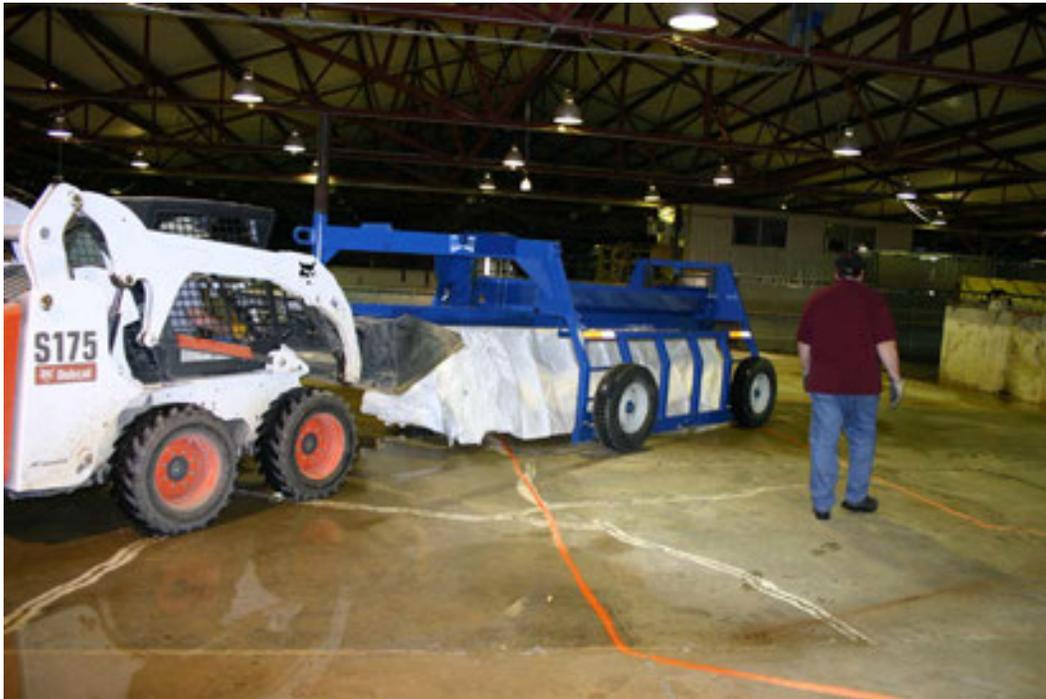
Figure 8. Trailer is loaded with bags and being towed to the test area.

The skid-steer was used to pull the trailer into the test basin (Figure 8). The bucket of the skid-steer was placed under the goose-neck hitch on the trailer and the skid-steer backed into the basin pulling the trailer. The trailer was not connected to the skid-steer.

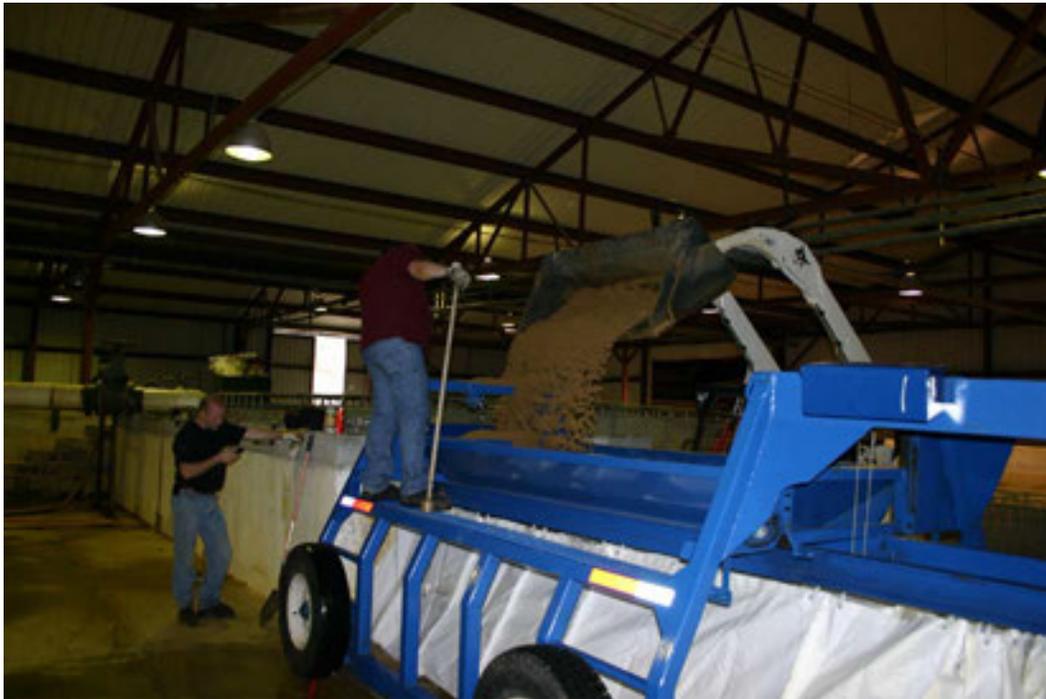
Figure 9. Sand is dumped into the hopper which holds the bags open and directs the sand into the bags.

Three men, including the skid-steer operator, erected the barrier. The other two men directed the dumping of the sand by the skid-steer, pushed sand into the corners of the bags, and compacted the sand with hand tampers to get a better seal. Tools required to fill the bags, in addition to the trailer and skid-steer, were shovels and hand-tampers.

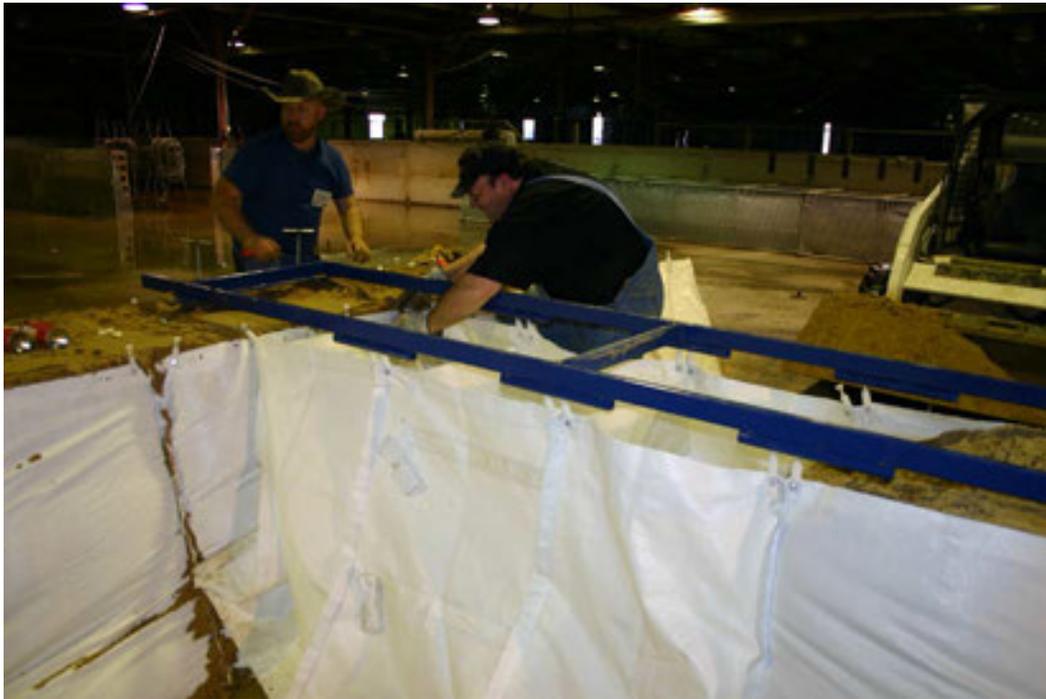
Figure 11. Portable frame used to hold bags open and in place where deployment trailer cannot be used.

To complete the connection between section “B” and section “C,” a portable frame was placed along section “C” and across the end of “B.” The portable frame had runners that supported the plastic tabs on the bags in the same way that the bags had been supported in the trailer (Figure 11). Excess bags in section “C” were cut off with a box cutter. The end of section “B” was extended one extra bag; the rest of the bags in the unit were cut off with a box cutter. Turnbuckles secured the bags from adjacent units.

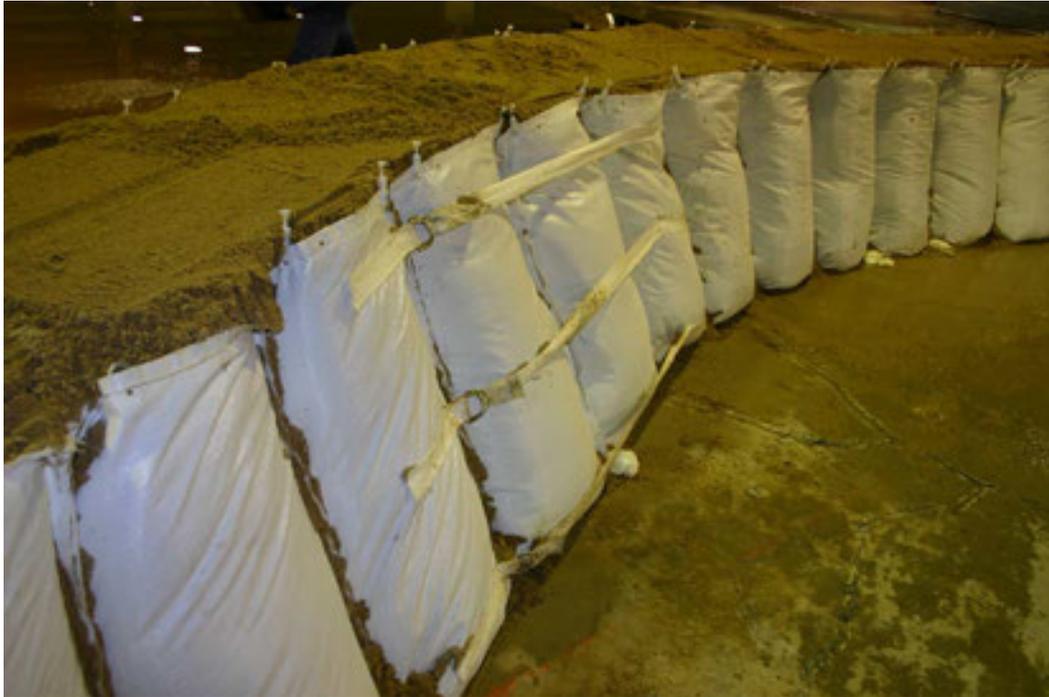
Figure 12. Straps fastened to "D" rings connect adjacent sets of bags.

The units are built with three straps on each side at one end of a 24-ft-long unit and three D-rings at the other end (Figure 12). Wire ties and vice-grip clamps were used to temporarily join the end bags from two adjacent units until they were full of sand (Figure 13). The straps from one unit are then run through the D-rings on the adjacent unit to form a secure connection, and the clamps are removed.

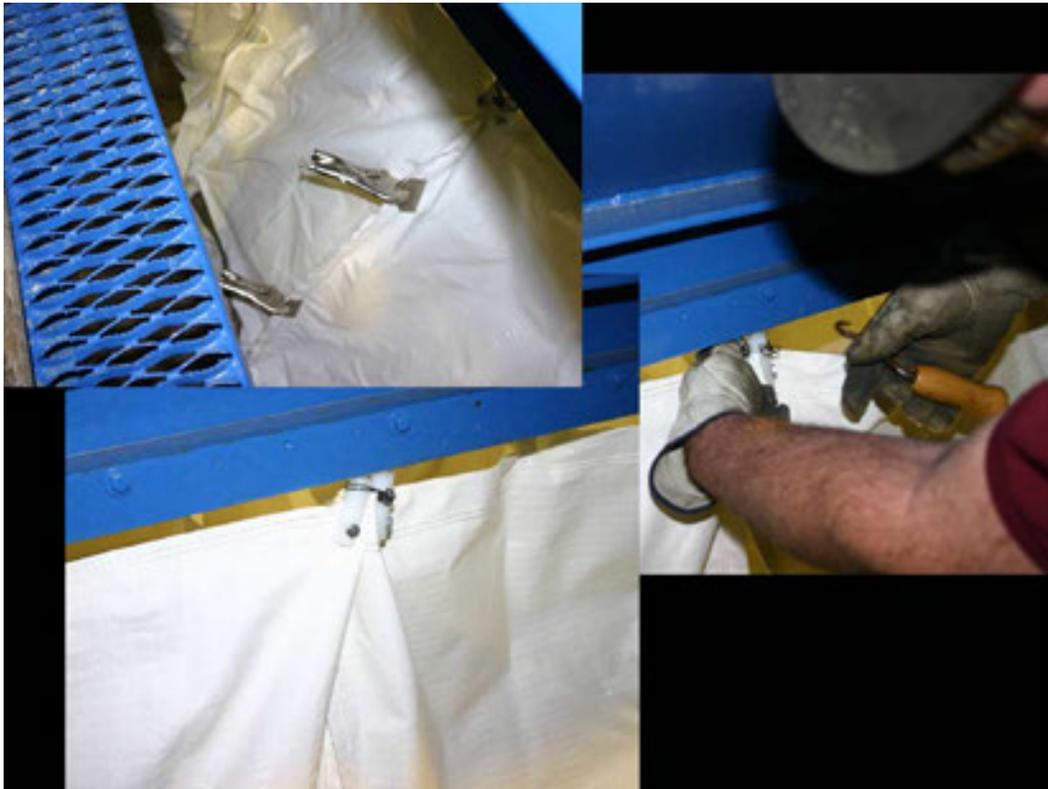
Figure 13. Baling wire around the mounting pins and vice-grip clamps hold adjacent sets of bags together.

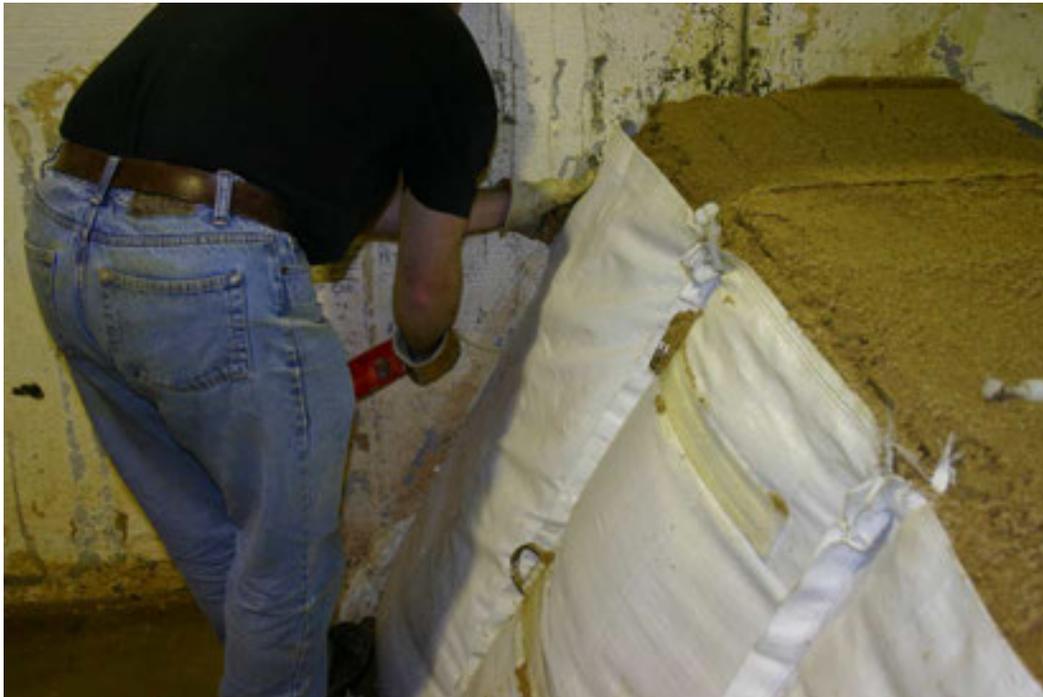
Figure 14. Expanding foam sealant completing the seal with the wingwall.

To connect to the wingwalls, expanding foam sealant was sprayed in the gap between the wall and the bags (Figure 14). Sealant was also used at the junction between wall “B” and wall “C”.

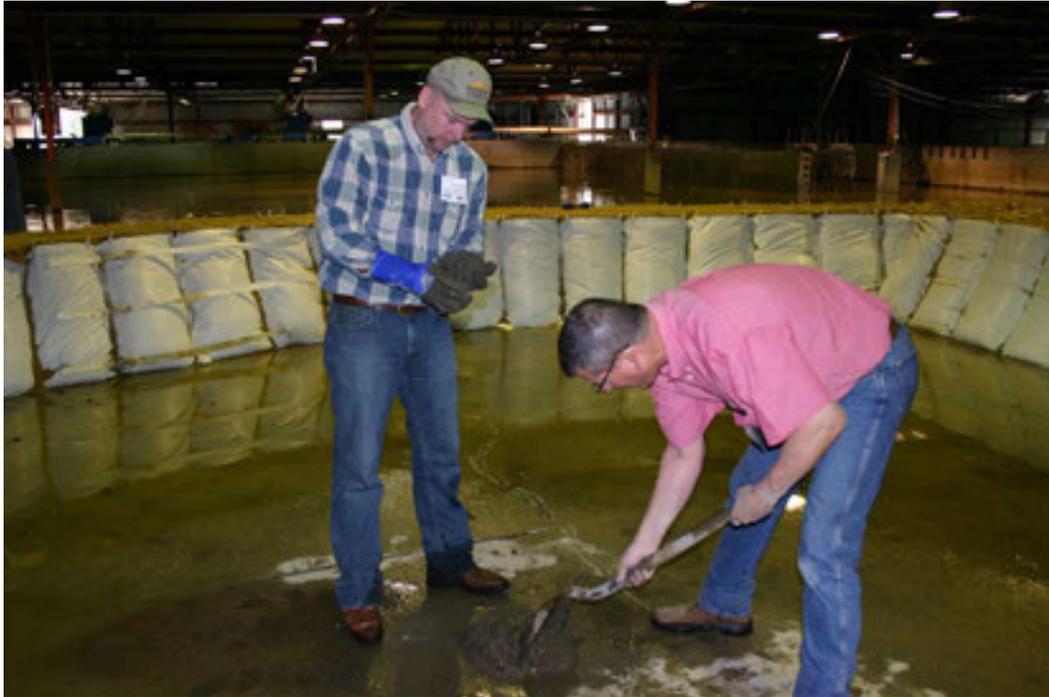
Figure 18. Concrete crack sealant being mixed in the test area.

Most of the seepage observed during the test with basin still water level (SWL) at 1 ft was coming through just a few of the seams between bags. The test was halted while a concrete crack sealant was applied both inboard and outboard of the seams with the most seepage. The sealant was mixed inside the test area using a shovel and plastic gloves (Figure 18) and placed both inside and outside the barrier on the seams where the seepage was highest (Figure 19).

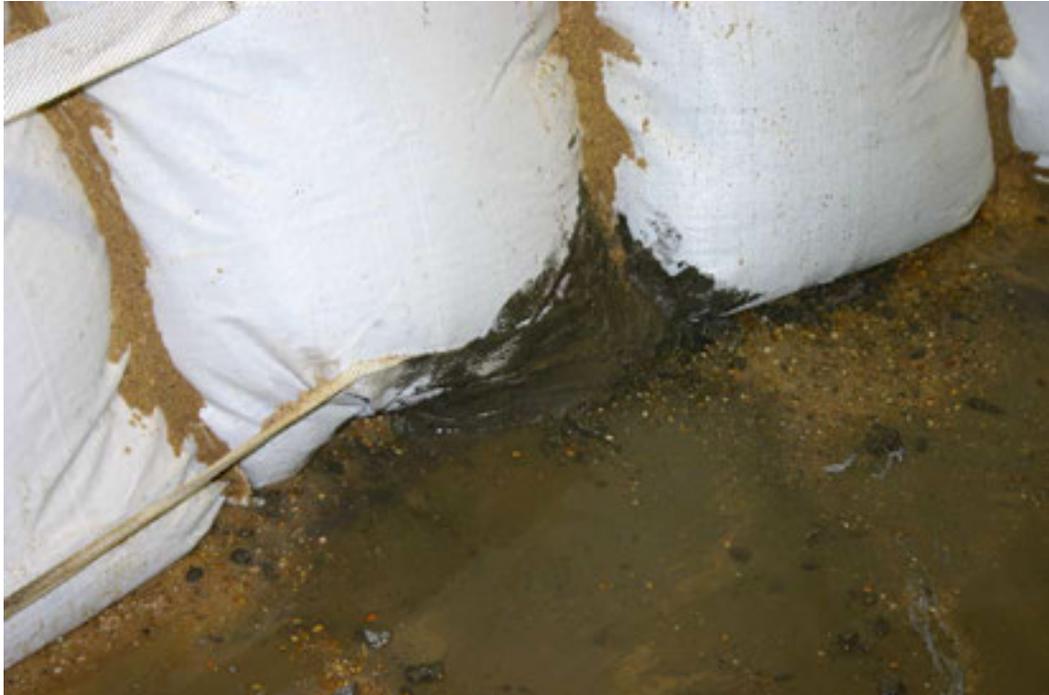
Figure 19. Concrete crack sealant applied to joint where seepage was high.

The repair took 1 hr 36 min, or 4.8 man-hrs. The sealant reduced the seepage rate to 0.20 gpm/ft. The amount of time required to make the repair exceeded the limit allowed by the Standardized Testing Protocol, therefore test results reported after this repair are not in compliance with the testing protocol.

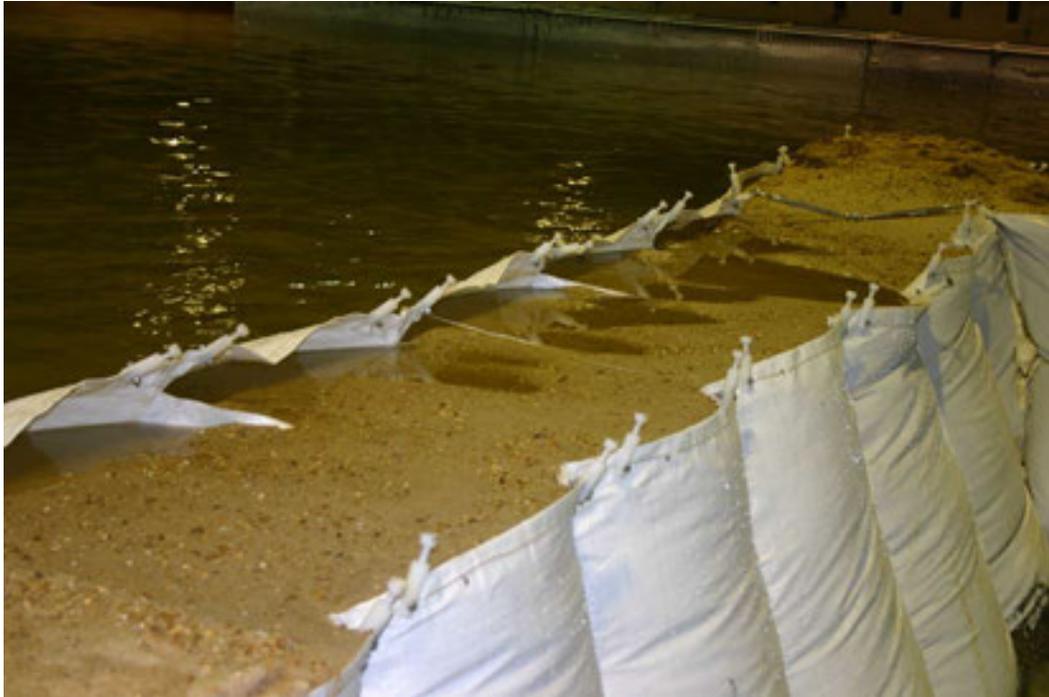
Figure 31. Washout along outer wall of wall "B" after test at low water with large waves.

The extra bag on the end of wall “B” that extended out past wall “C” showed no evidence of damage (Figure 31).

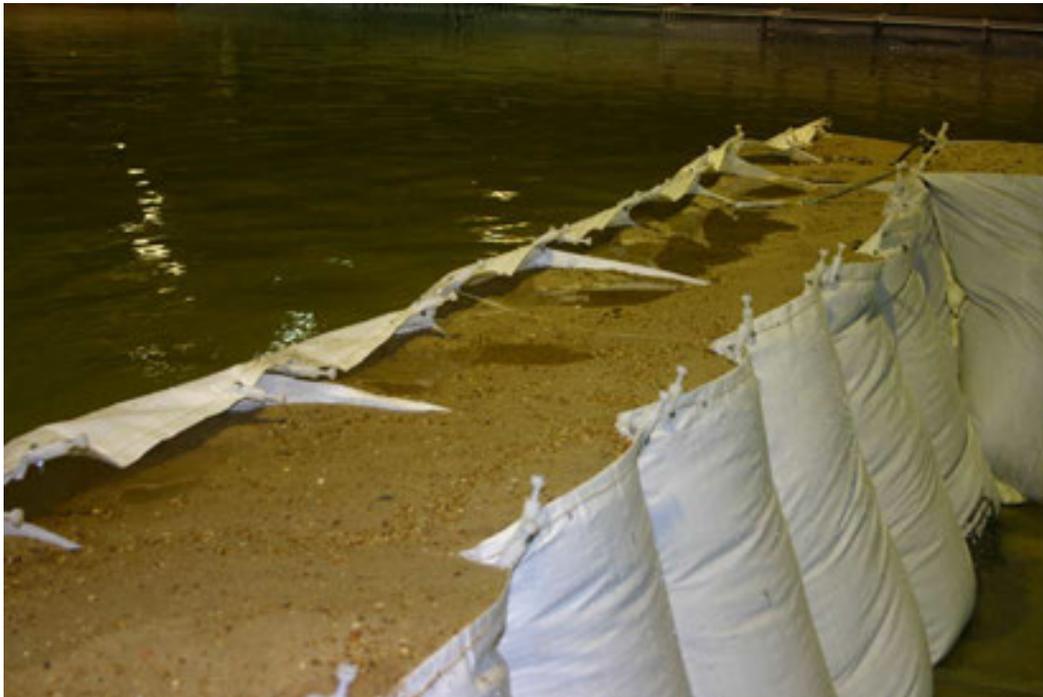
Figure 34. Wall "B" showing washout along outer wall of barrier at conclusion of test with medium waves at high water.

In general, the sand in the washout areas was taken down to the level of the internal baffles, then stabilized. The top edge of the internal baffles is lower than the outer walls of the bags, and also can sag somewhat in the middle of the bag. As seen in Figure 34, the sand is pushed in towards the inner wall but scoured out along the outer wall.

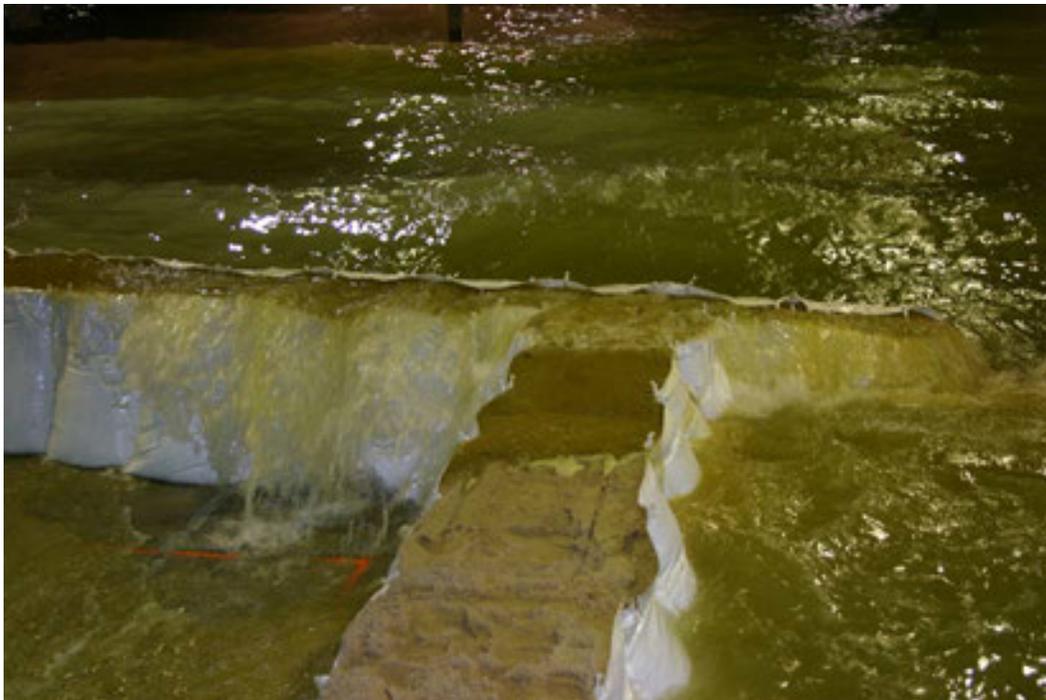
Figure 35. Overtopping along wall "B" during test with large waves at high water.

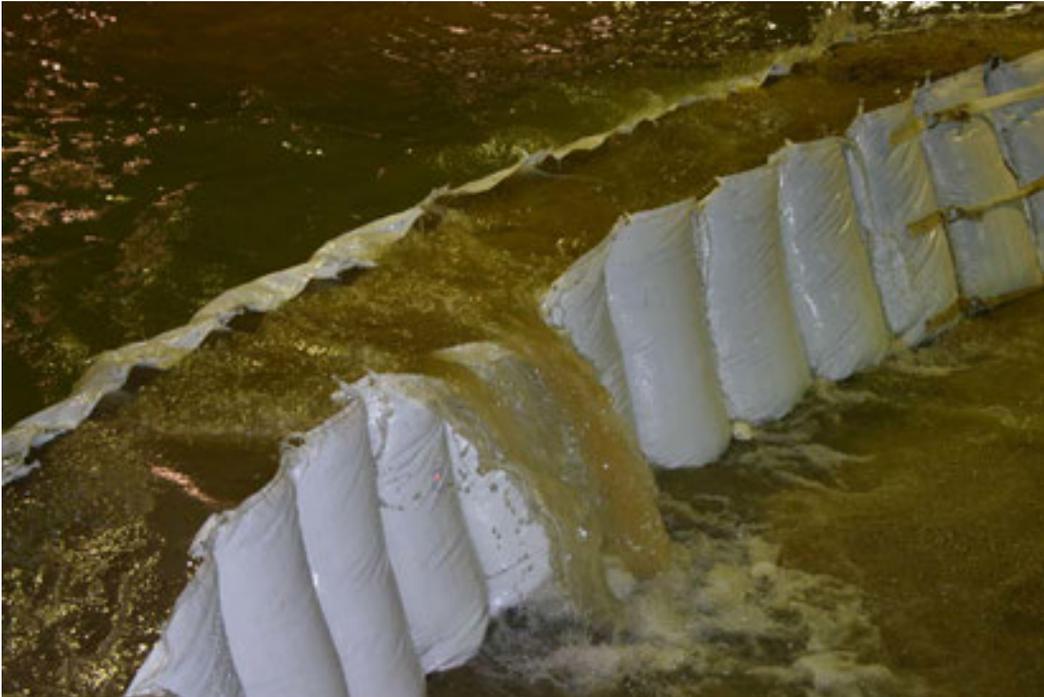
Figure 36. Wave overtopping along wall "A" during test at high water level with large waves.

Along the curve of wall “A”, the overtopping was concentrated in an area about 5 ft out from the wingwall (Figure 36). Not only did overtopping flow over the inner wall at this point, but overtopping water collected along much of wall “A” flowed along the top of the barrier and flowed over the inner wall at this point.

In Figure 39, it appears that wall “A” is moving inward nearly one-half inch during the waves tests. However, Figure 36 showed overtopping of large waves at high water running across wall “A” in the vicinity of the laser target. The flow of water from tests at both medium and large waves knocked down the top couple of inches of the inner wall of the barrier in that area, forming a channel through which the overtopping could cross the inner wall of the barrier. It is probable that the overtopping water pressure on the inner wall caused a shift in the fabric to which the laser target is attached. There was no apparent movement of the barrier wall.

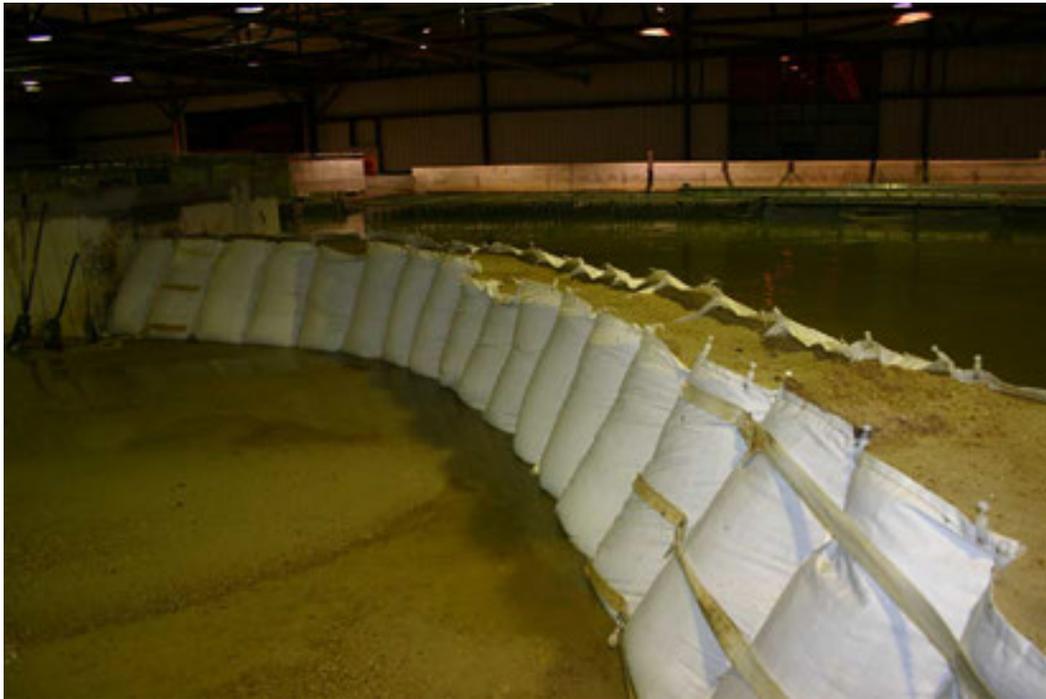
Figure 37. At the conclusion of the waves tests, looking along wall "B" towards the curve of wall "A".

At the conclusion of the tests with waves, the bags had lost a couple inches of sand but were still stable and secure.

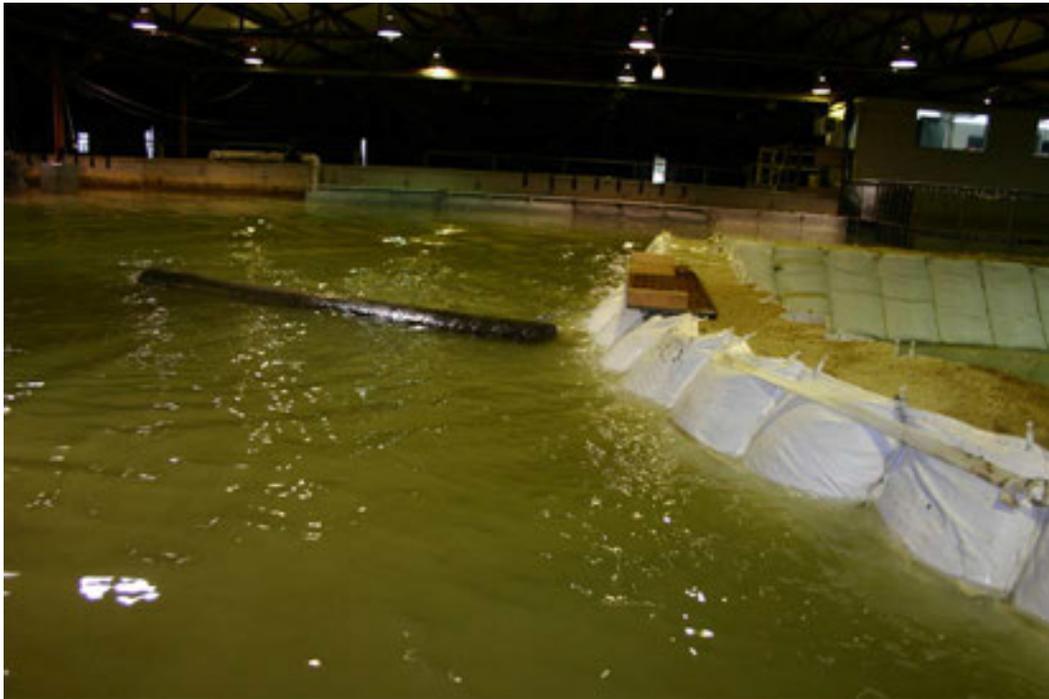
Figure 41. Immediately after log impact on barrier. The plywood on top of the barrier is to protect the barrier from the tow cable.

The two logs were towed into the structure one at a time, the smaller log first (Figure 41 and Figure 42). Neither log caused any noticeable damage to the structure,

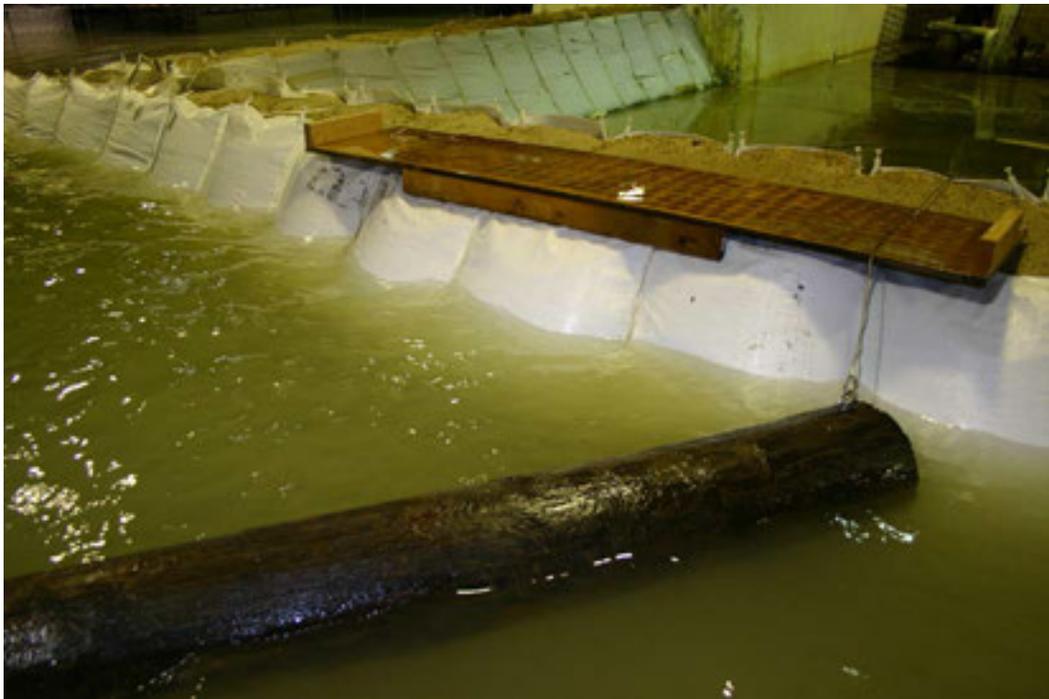
Figure 42. No damage to the barrier could be found.

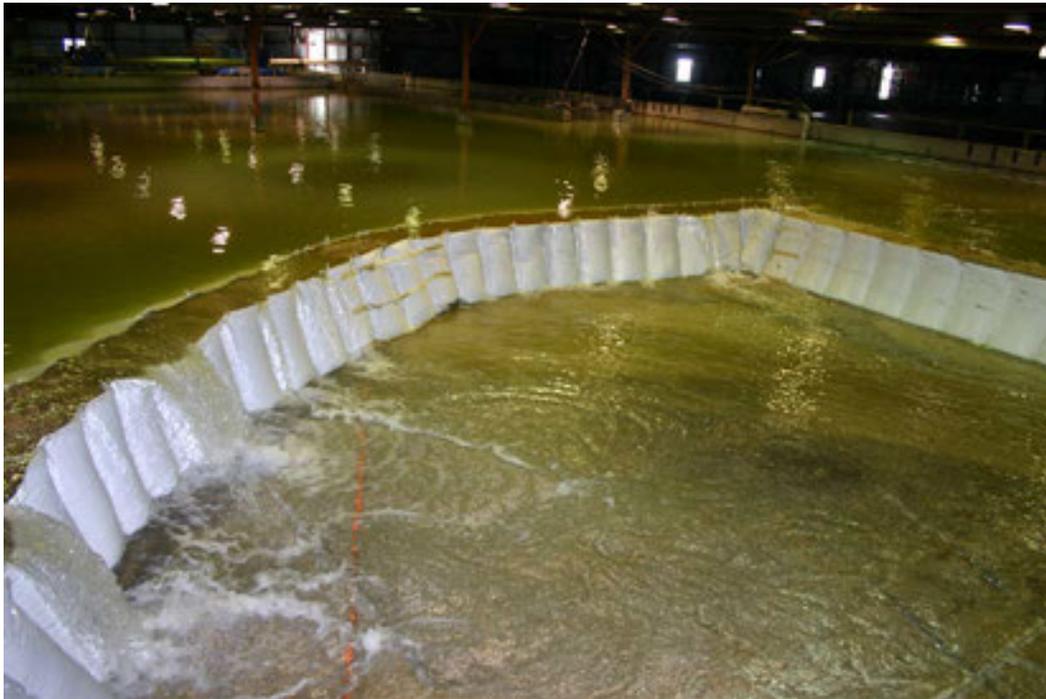
Figure 43. Water flowing over the structure during the overtopping test.

After one hour of overtopping with an average depth of flow of 1 in., there was one scour hole-10 in.-deep along the inner wall on the curve of wall "A" and about 6-in.-deep at the point of maximum flow over the inner wall. Wall "C" had shown very little overtopping and no damage. The extra bag at the end of wall "B" had scoured to the height of the interior baffles but then stabilized. Much of wall "B" had scoured to the height of the interior baffles, but then stabilized.

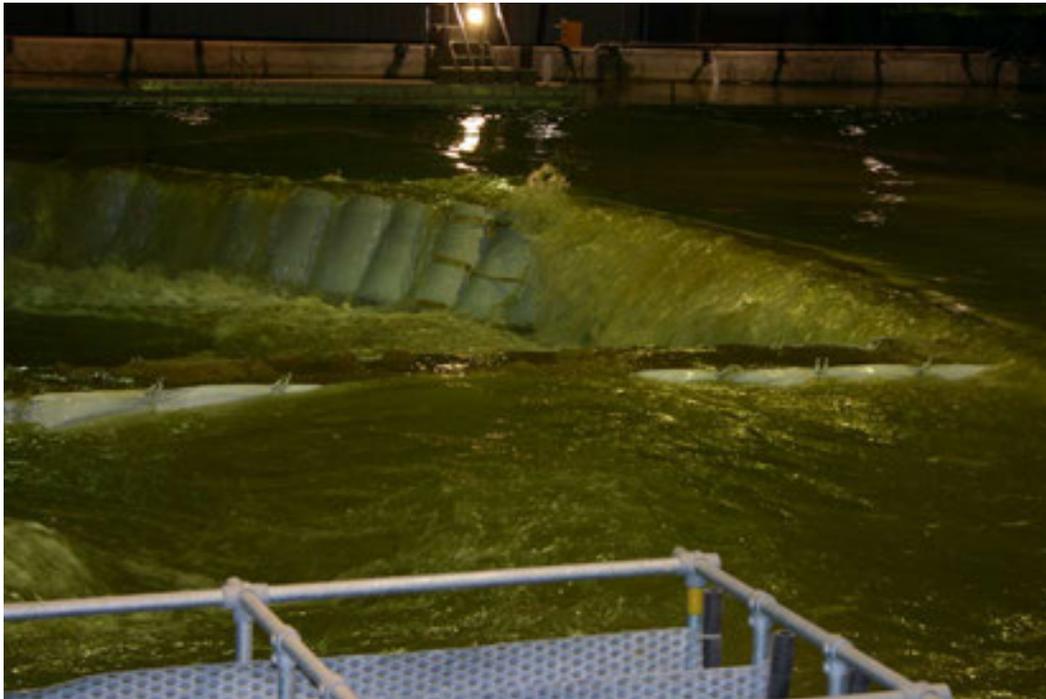
Figure 44. Large waves added to the overtopping test.

At request of the vendor, waves were added to the basin while water was still overtopping the structure. Small waves with a 2 in. wave height were run for 3 min, then 6- to 8-in. waves were run for 1 min, and 10-in. wave were run for 15 sec (Figure 44). The diesel pumps could not keep up with the overtopping when the large waves were added, so the waves were stopped after only 15 sec, but the barrier was not endangered. The barrier was not noticeably affected by the waves and remained stable.

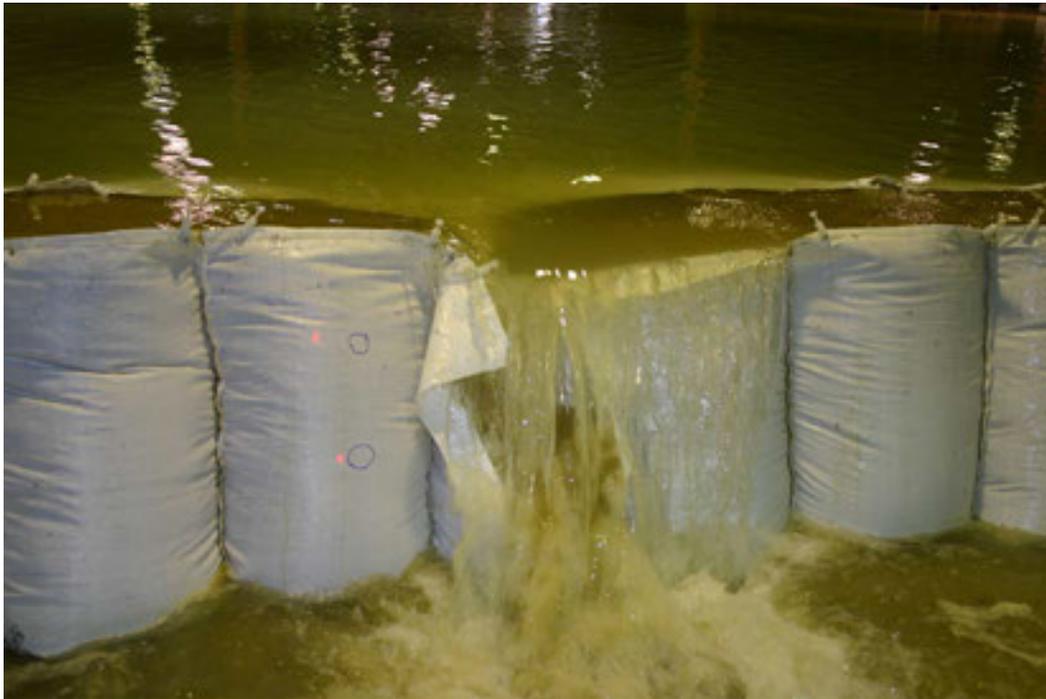
Figure 45. One bag cut open with water still overtopping structure.

The drain was then opened to empty the basin. However, while the water was still overtopping the structure one of the bags in wall “B” was sliced open along the inner wall to test the ability of the barrier to withstand being damaged. The overtopping water quickly washed the sand out of the damaged bag. The walls of the adjacent bags bulged inward along the centerline of the barrier making a smaller opening where the cut bag had been, while the fabric held and the damage did not spread to other bags (Figure 45). The outer wall of the damaged bag was pushed inward by the water pressure. The top of the outer wall where it was pushed into the damaged bag was 18 in. below the top of the other bags. A pile of sandbags placed in front of the damaged RIBS bag would have stopped much of the flow through the damaged bag. In Figure 45, movement of the bag adjacent to the one that was cut when it bulged over into the opening left by the cut bag is apparent from the lasers and the circles where the lasers had been pointing.

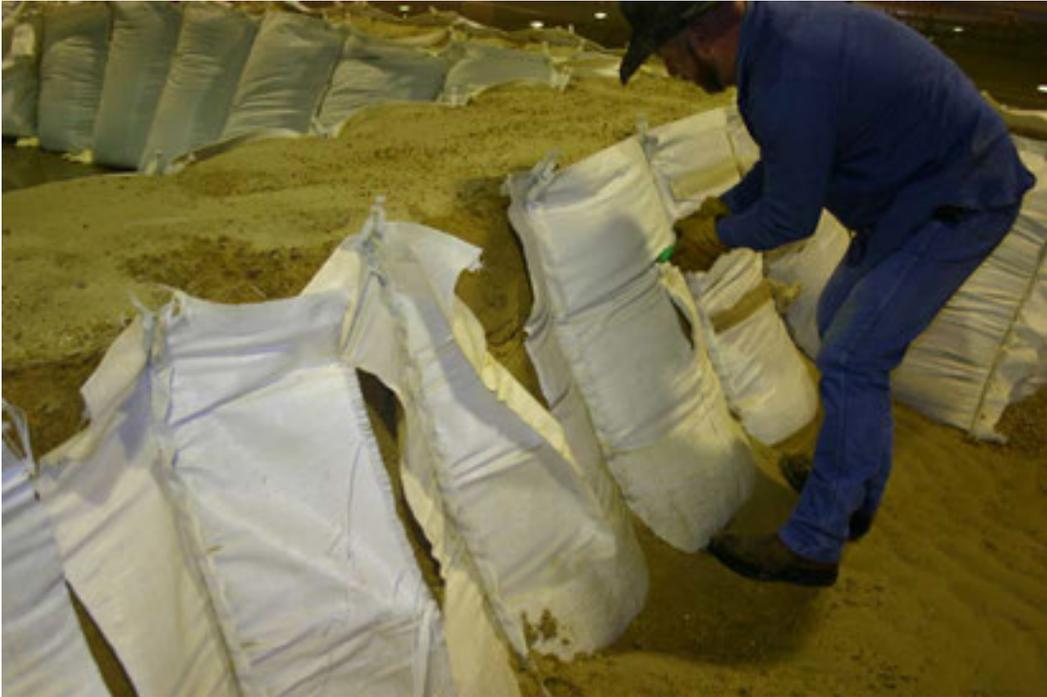
Figure 46. For removal, a box cutter is used to slice open the bags on both the inside and outside.

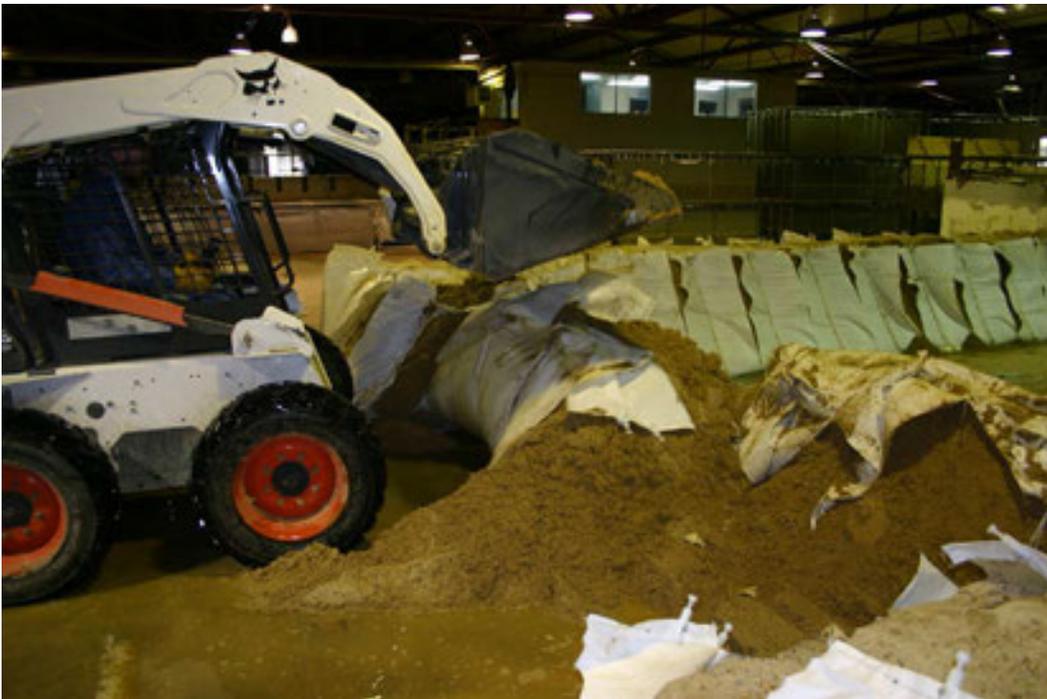
Figure 47. A skid-steer loader is used to roll the bags over, dumping out the sand.

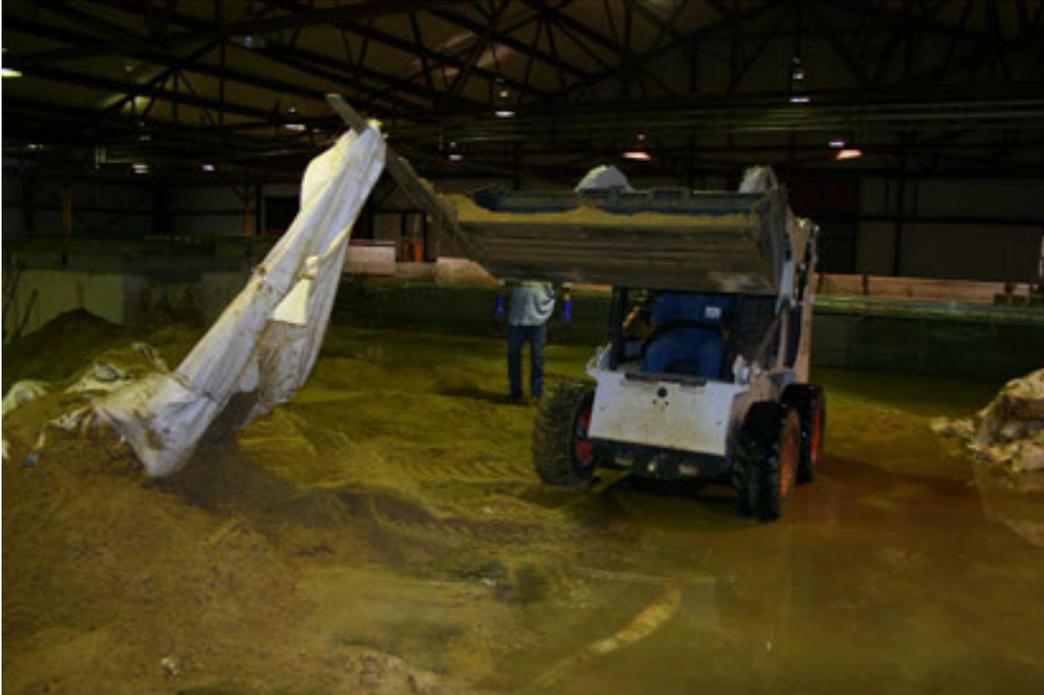
Figure 48. One extension fork is fastened to the front of the bucket to remove the bag material from the sand.
